# Sellersburg School Facility Conditions Assessment

PREPARED FOR:  
The Town of Sellersburg  
206 N New Albany St., Sellersburg, IN 47172

April 5, 2024

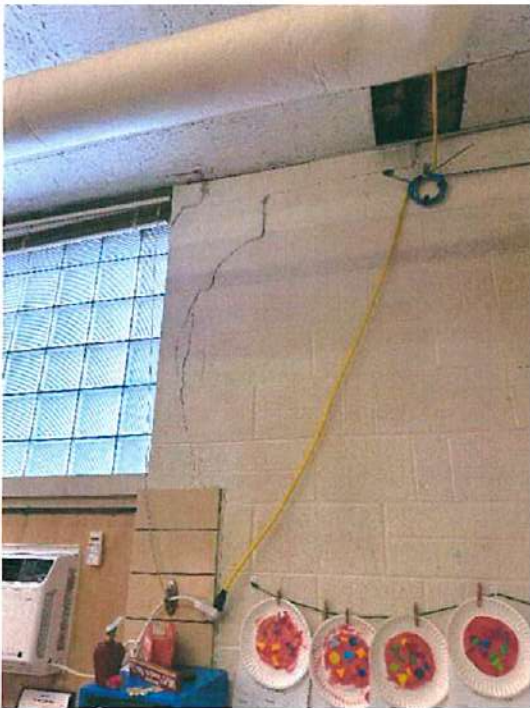
**Photo A3**  
First Floor – Some cracking of exterior wall possibly due to foundation settlement

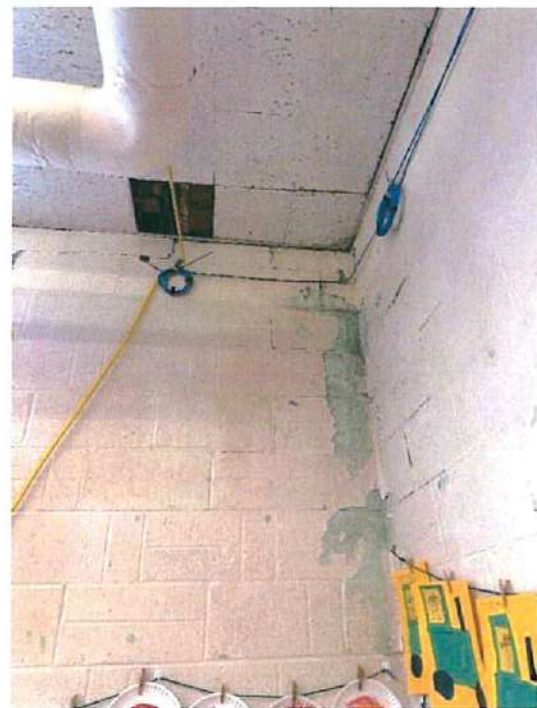
- The corridors and many of the classrooms in the original part of the building have a 4'-0" tile wainscot.
- Sections of paint on many interior faces of exterior CMU walls have been damaged by water leaking in through the roof (See Photo A4).

**Photo A4**  
First Floor – Damage to paint due to water seepage at exterior walls

- The majority of the damage to interior finishes is from water intrusion. Damaged finish materials including plaster, flooring, ceiling tiles, and miscellaneous wood shelving. All water damaged finishes should be replaced.
- Clean ceiling, wall and floor surfaces damaged by water intrusion, reseal
- Complete removal of all lay-in ceilings will probably be necessary in order to install new mechanical and electrical systems. Install new lay-in ceilings throughout the building.
- Seal any cracks in ceilings, walls, and floors.
- Replace all steel and glass block windows.
- New sealant at windows, and at control joints
- Tuckpoint brick façade of original building.
- Clean brick and stone facades. Apply water repellent to brick.

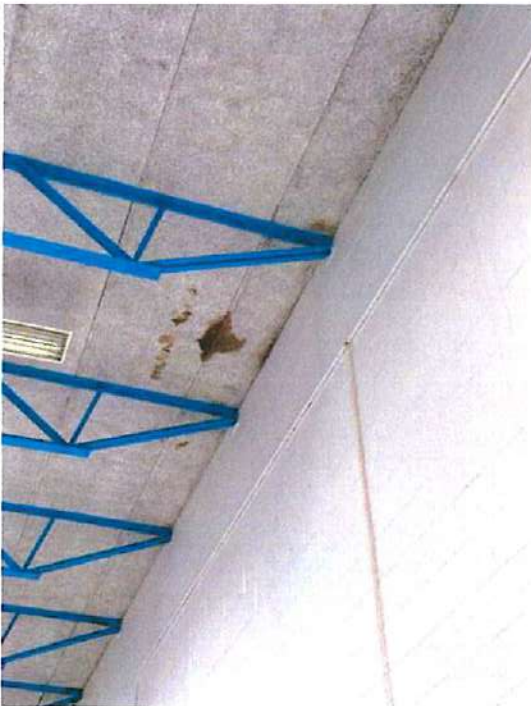
**Photo A7**  
First Floor – Gymnasium; Water damage on some tectum panels

- Add new exterior handrails where they are missing.
- Remove current roofing systems down to wood deck at original building, concrete deck at classroom addition, and tectum panels in gymnasium. Replace any damaged wood deck or tectum. Replace roofing systems with tapered rigid insulation and a single-ply membrane roof.

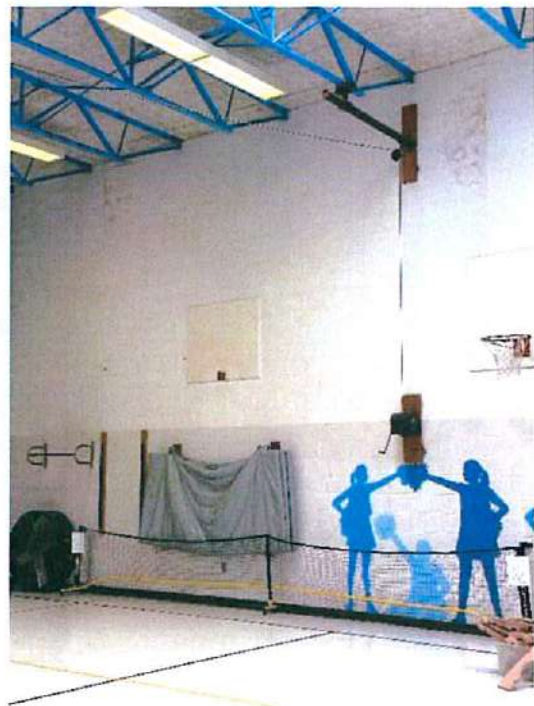
**Photo A8**  
First Floor – Gymnasium; Water damage at some sections of wall

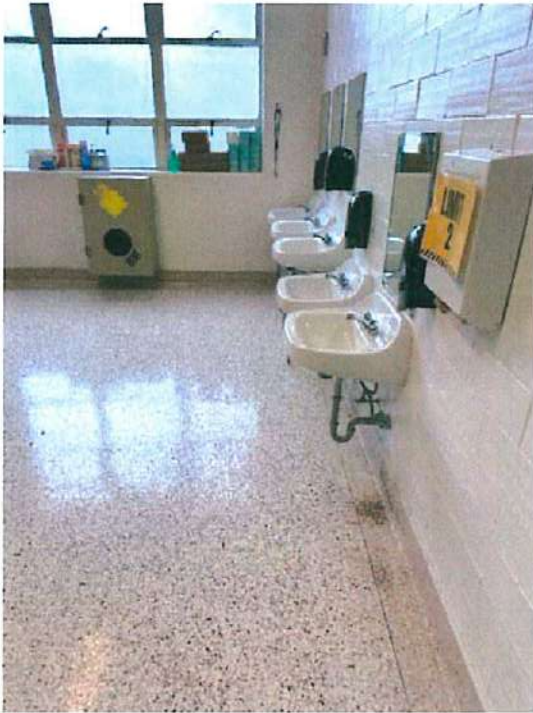
**Photo A9**  
First Floor – Restroom sinks that will need to be adjusted in height for adults.

- The lavatory sinks and faucets are recommended for replacement with low flow ADA approved Faucets. Sink trap ADA wraps are missing and are recommended for replacement and thermostatic mixing valves are required on hot water supply lines to meet Plumbing Code requirements. Several faucets are missing handle and not operational, replacement is recommended.

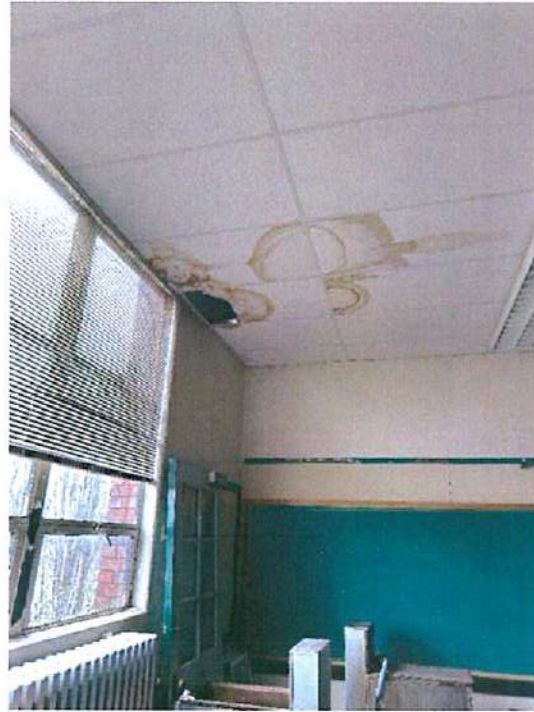
**Photo A14**  
Third Floor – Water damage to ceiling tiles

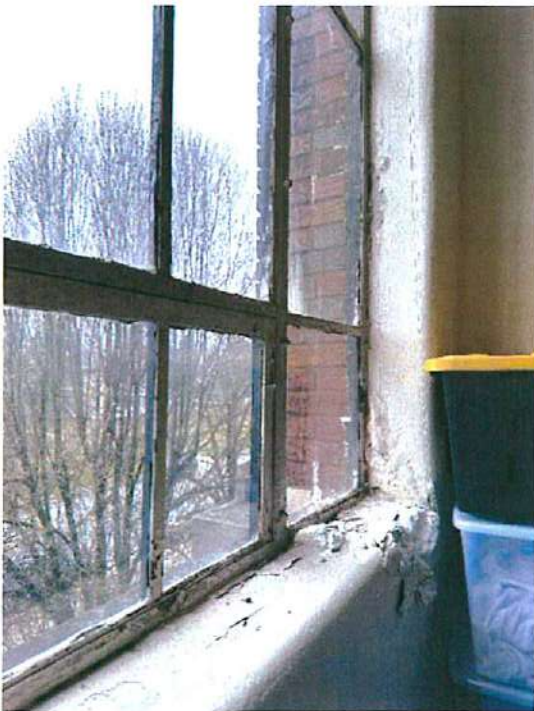
**Photo A15**  
Third Floor – Damage from water intrusion at window

- Depending on future design, some interior doors could be salvaged.
- Interior walls will need to be repaired at window openings.
- Terrazzo appears to be in relatively good condition in restrooms and second and third floor corridors; patch cracks and polish.

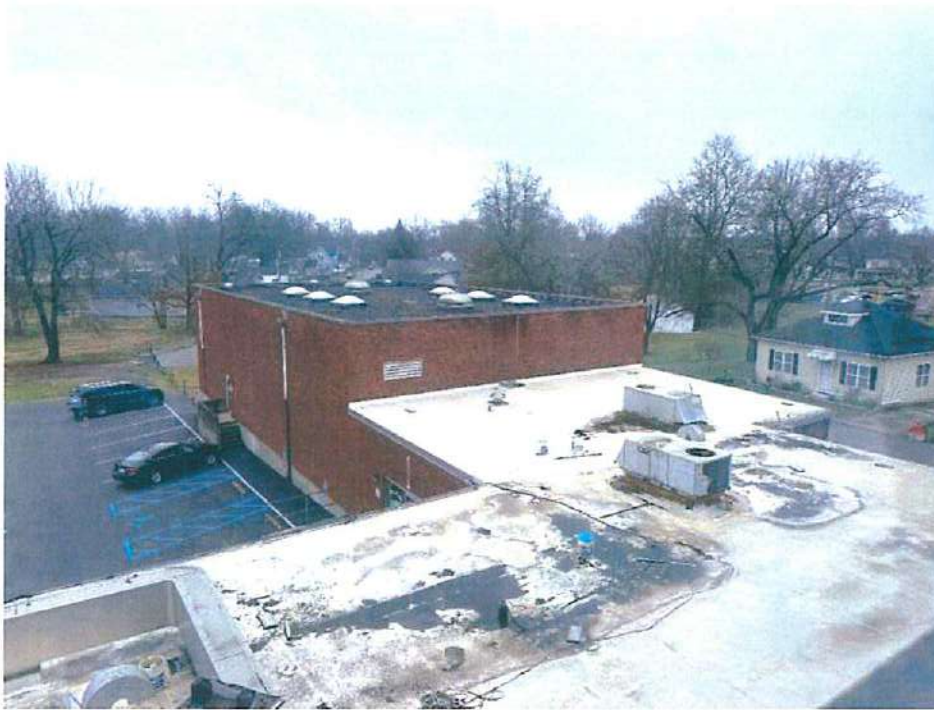
- Much of the water intrusion damage throughout building is due to failure of roofing systems. The lower roof portion over the 1954 addition is not correctly sloped and is resulting in a large amount of standing water.

**Photo A17**  
Roof – Standing water on roof

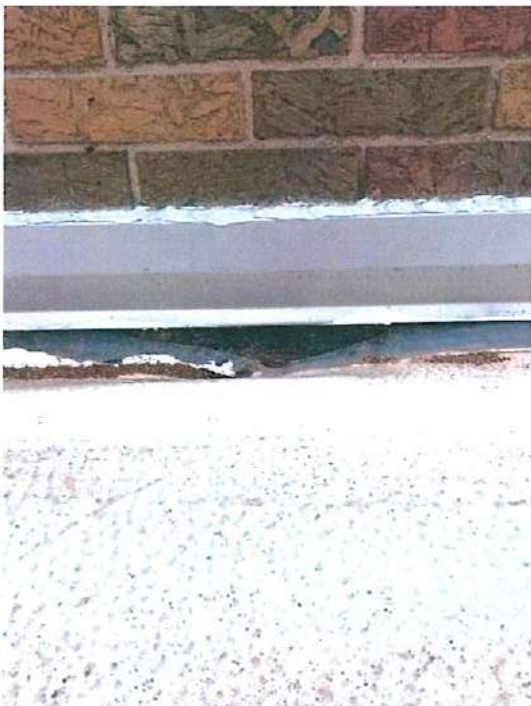
- The observed roof membranes are significantly worn and were not installed correctly. A roof coating has recently been applied to the membrane roof, but the application is poor and does not address the underlying issue of the roof not being sloped properly.

**Photo A18**  
Roof – Membrane not attached properly

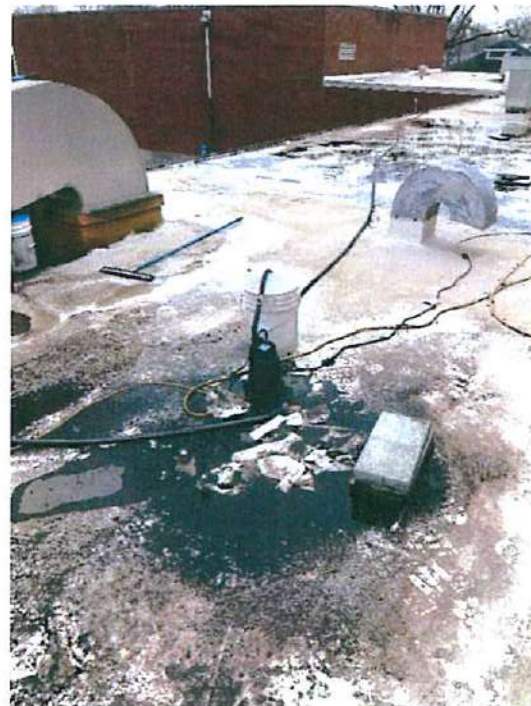
- Sump pumps are currently placed on the roof to remove the standing water.
- Some downspouts are disconnected, resulting in water dripping down façade of building. This could be the cause of some of the moisture migration through the masonry bearing walls into the building.

**Photo A19**  
Roof – Sump pumps currently on roof to remove standing water

- There was no functional roof drain observed on the roof, and the roof is not sloped for proper drainage. The accumulated stormwater and condensate discharge from the HVAC equipment rely solely on a couple sump pumps to automatically pump the excess water out of roof level out to the gutters and downspouts system on the side of the building. However, the sump pumps are not functioning as intended occasionally and hence caused significant amount of built-up water on the roof during the site visit. As a result, this causes major slipping hazard for any type of maintenance work on the roof.

- Install roof drains and stormwater draining system in accordance with the new roofing replacement and requirements.
- Sanitary vent risers will need to be installed to serve the upper floors if the renovation involves any addition of plumbing needs on the upper floors. Routing and tie locations do not yet exist.

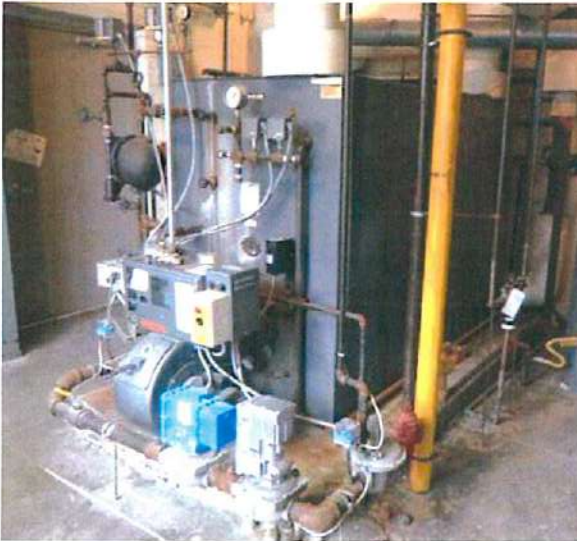
**Photo M/P1**  
Gas-to-Steam Boiler

- The existing steam boiler and associated steam piping shall be removed. The affected piping penetrations shall be patched and sealed. The gas-to-steam boiler shall be replaced with a hydronic heating hot water condensing boiler with high efficiency and associated recirculation pumps.

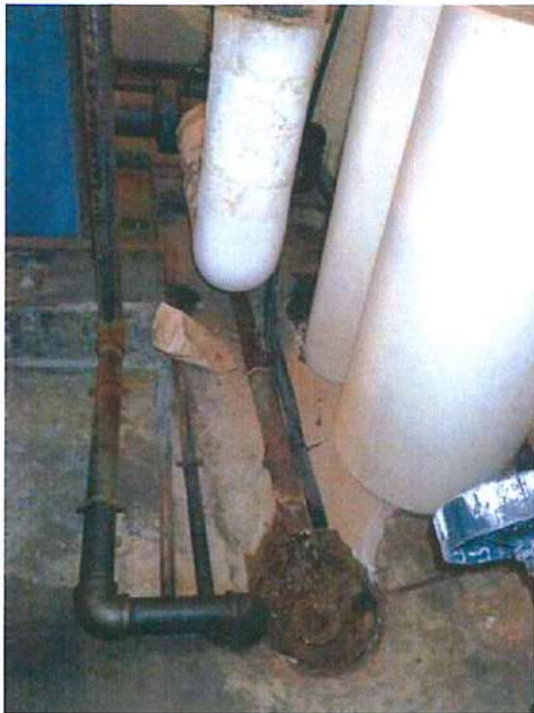
- Floor drains in the utility and related areas show significant signs of corrosion due to clogage in the past. It is recommended to place all the floor drains.

**Photo M/P5**  
Floor Drain Condition

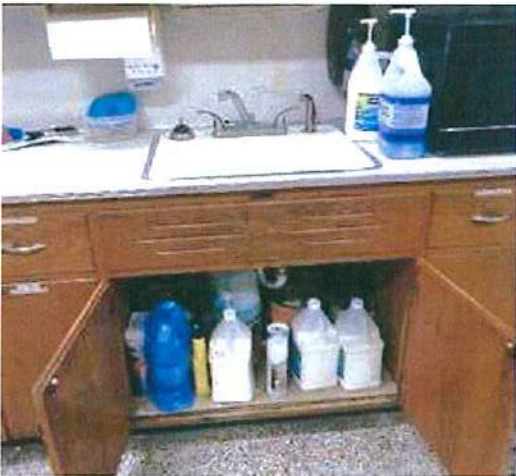
- There is a faucet and a commercial type two-compartment kitchen sink in the Kitchen. The faucet, two-compartment sink, and their associated traps and piping all have moderate signs of corrosion due to aging and wear, it is recommended for removal and replacement in its entirety.

**Photo M/P11**  
Kitchen Faucet

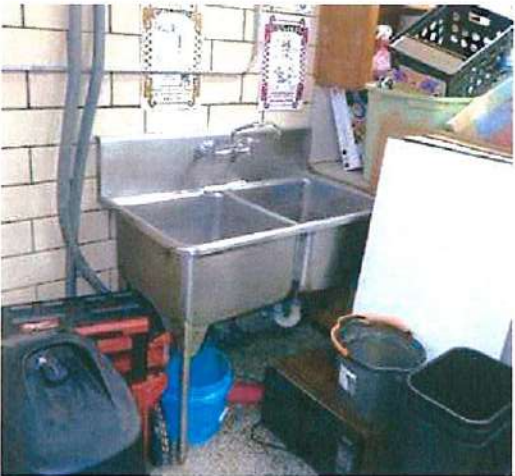
**Photo M/P12**  
Kitchen Commercial Sink

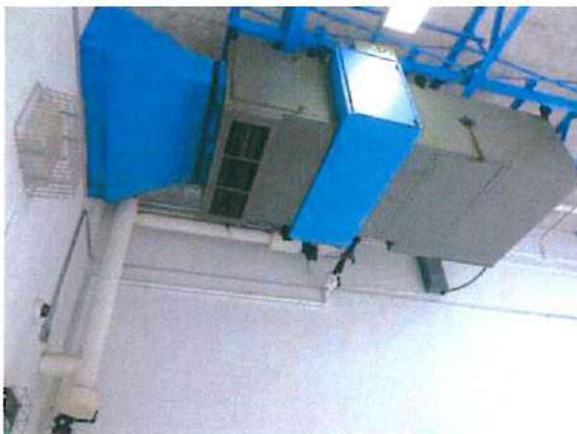
- Heating and Ventilating Unit:  
There is a heating and ventilating unit that is used to serve the gymnasium with an approximate steam heating capacity of 180 MBH. This structural suspended heating and ventilating unit is also supposed to be interlocked with two roof mounted relief air hoods for air relief when air temperature rises above the set temperature. However, this system is currently not in operation and has not been in functional condition for the past years due to numerous incidents of condensate leakage and pipe cracks.

**Photo M/P15**  
Gymnasium – Heating and Ventilating Unit

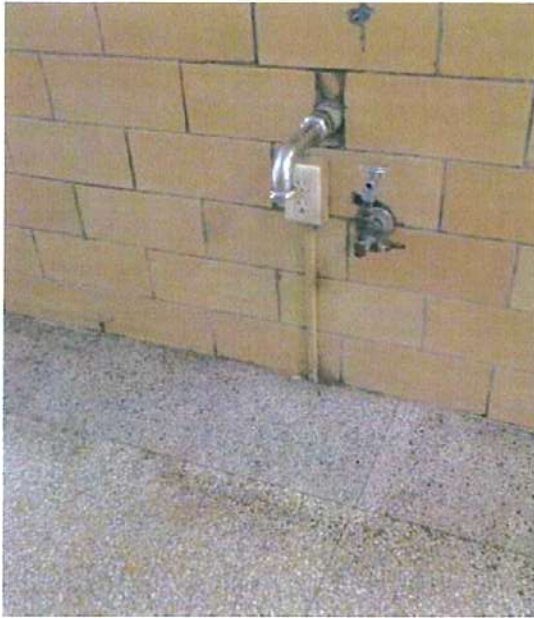
**Photo M/P17**  
Safety Code Violation – Potential Water Contact  
with Electrical Receptacle

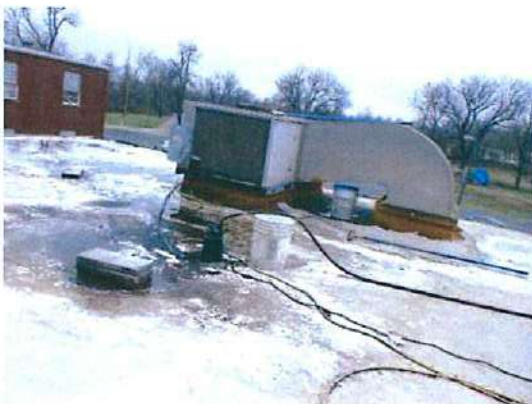
**Photo M/P19**  
Typical Rooftop Unit and Adjacent Condensate  
Discharge Condition
